SAFETY NOTICE NO: MS-909-SN-1

DATE/REV: 1 Feb 2022 REV 0

ATTENTION: OWNERS / OPERATORS OF MODEL 909 CARGO HOOK
INSTALLED ON UH-60 HELICOPTERS.

SUBJECT: PROPER USE OF THE COCKPIT MANUAL RELEASE

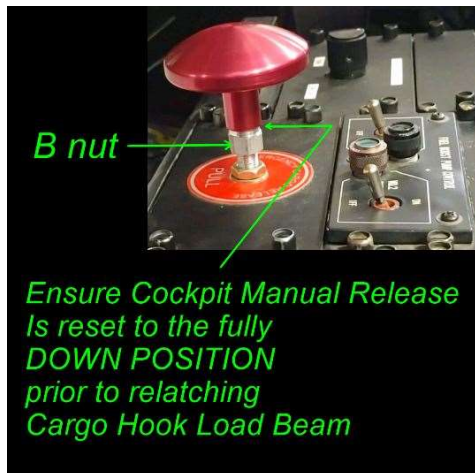
FIGURE 1

During initial installation of the manual release cable, the B nut (figure 1) capping the manual release cable housing directly under the release handle can be tightened to increase friction on the manual release. This allows the operator to adjust the release friction based on their own preference.

When the B nut is loose (low friction) the handle will generally retract due to gravity. When B nut is adjusted to add resistance, the handle will not retract with gravity and must be manually returned to the retracted or reset position prior to resetting the hook load beam.

If after a cockpit Manual Release use, the operator fails to reset the cockpit control (figure 1) prior to resetting the load beam **and** sufficient friction has been adjusted into the cockpit control to prevent the handle from resetting with gravity, a condition may be present where the Load Beam is prevented by the cockpit control from returning to the locked position. This can be clearly visualized as the cockpit control was left in the “release” position therefore the Cargo Hook will also be in the “release” position.

1. Cockpit Manual Release control- Pull to release external load
2. Cockpit Manual Release control – Push down fully to reset
3. Cargo Hook –Relatch Load Beam and ensure Cargo Hook Manual Release Knob (Located on the right side of the Cargo Hook, figure 2) is fully rotated in the clockwise direction.

Note: If the cockpit Manual Release B nut is adjusted to increase or decrease friction after initial installation, Manual Release rigging should be checked per MSI-MNL020 dated June 11, 2018 or later revision (available at mechspecialties.com). This entails ensuring the manual release cable ball end has a minimum of .050" gap from the release arm with the cockpit control and the hook in the reset and locked positions.
