TECHNICAL BULLETIN

Technical Bulletin No.: **TB-901-20-01**
Cargo Hook Model No. 901
Date: March 10, 2020
Page No.: 1 of 4
Rev.0

SUBJECT: Cargo Hook Keeper Modification.

MODELS AFFECTED: Model 901

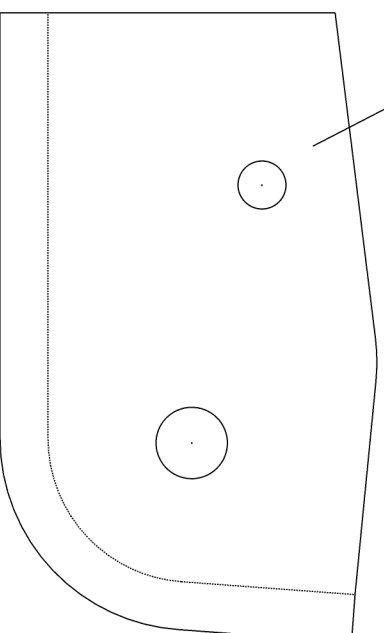
KEEPER DRILLING TEMPLATE

DRILL 1/4" HOLE

3. Remove keeper assembly and keeper spring, reference page 13, items #79 & #78.
4. Modify keeper, item #79 as follows:
 - a) Overlay the provided template (Page 4) on the side of keeper and mark location of hole to be drilled. One method to accomplish this task is to utilize an automatic center punch. Place point of punch at the center of the bolt location on the template and punch through the template thereby marking keeper for drilling.

- b) Repeat step 'a)' on the opposite side of the keeper by utilizing the opposite side of template.
 - c) Place keeper in non-marring or soft-jaw vise, preferably in a drill press.

- d) Utilizing a .250 bit, Drill one hole from each side of keeper at the position of the punch marks; do not drill from one side all the way through second side, as this could improperly position the bolt on assembly.
